1. AGENCY USE ONLY (Leave blank)		2. REPORT DATE Febraruy 2001	3. REPORT TYPE AND DATES COVERED Inspection	
4. TITLE AND SUBTITLE Lower Granite Dam Radial Gate Inspection and Testing			5. FUNDING NUMBERS

# Lower Granite Dam

## Radial Gate Inspection and Testing

US Army Corps of Engineers, Walla Walla District

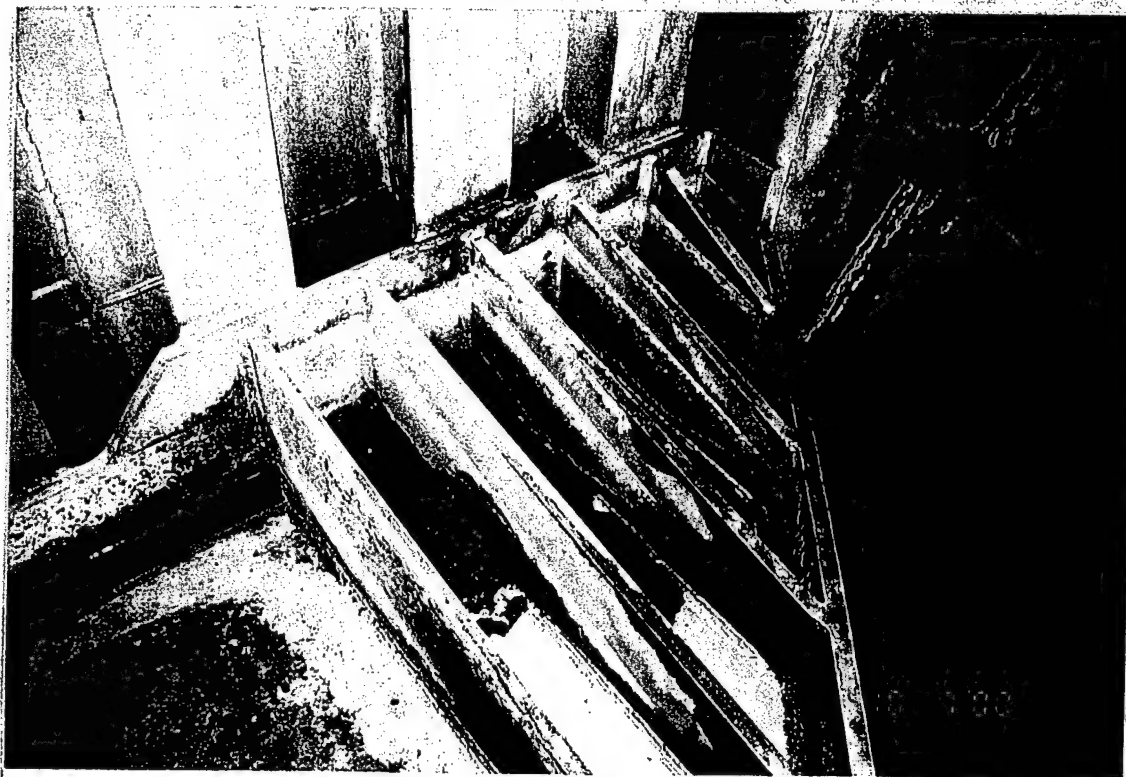
Left end of bottom horizontal girder.  
Standing water, no drainage between  
multiple stiffeners. Horizontal girder  
to skin plate stiffeners, standing  
water, debris and no drainage

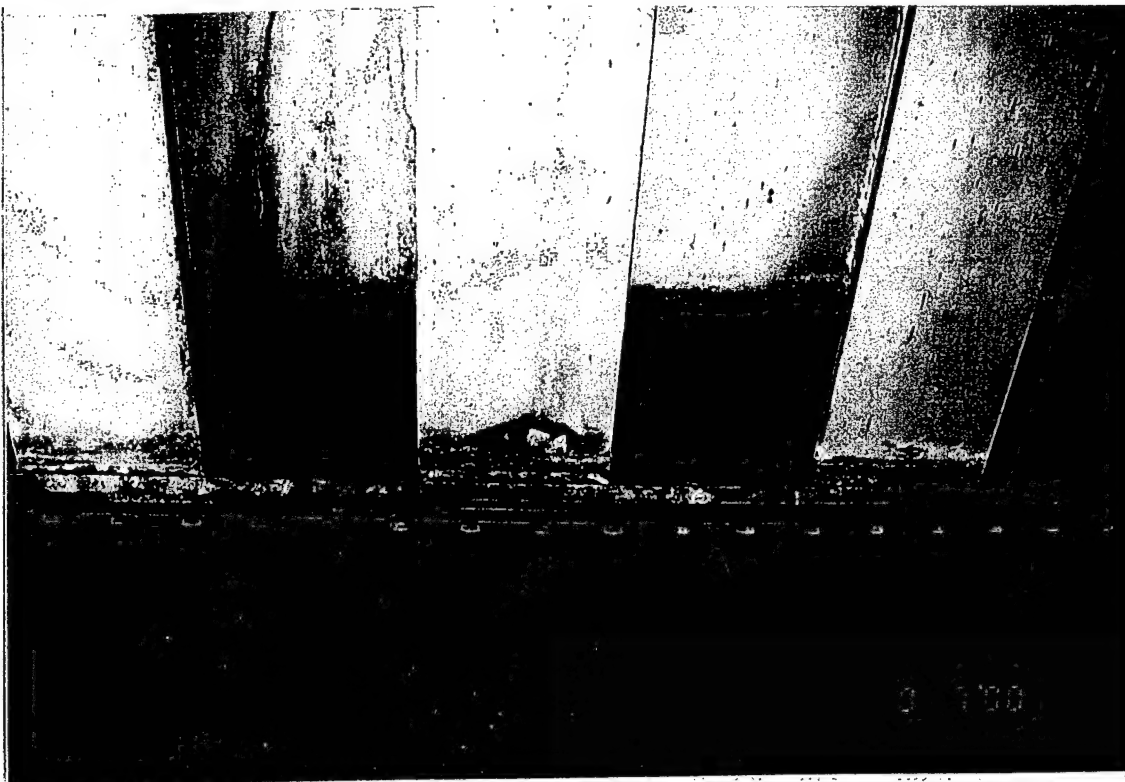
7-3

**Gate 7**  
Bottom seal closure plate looking  
upstream. Standing water between  
closure plate, purlin webs and  
skinplate. Typical.

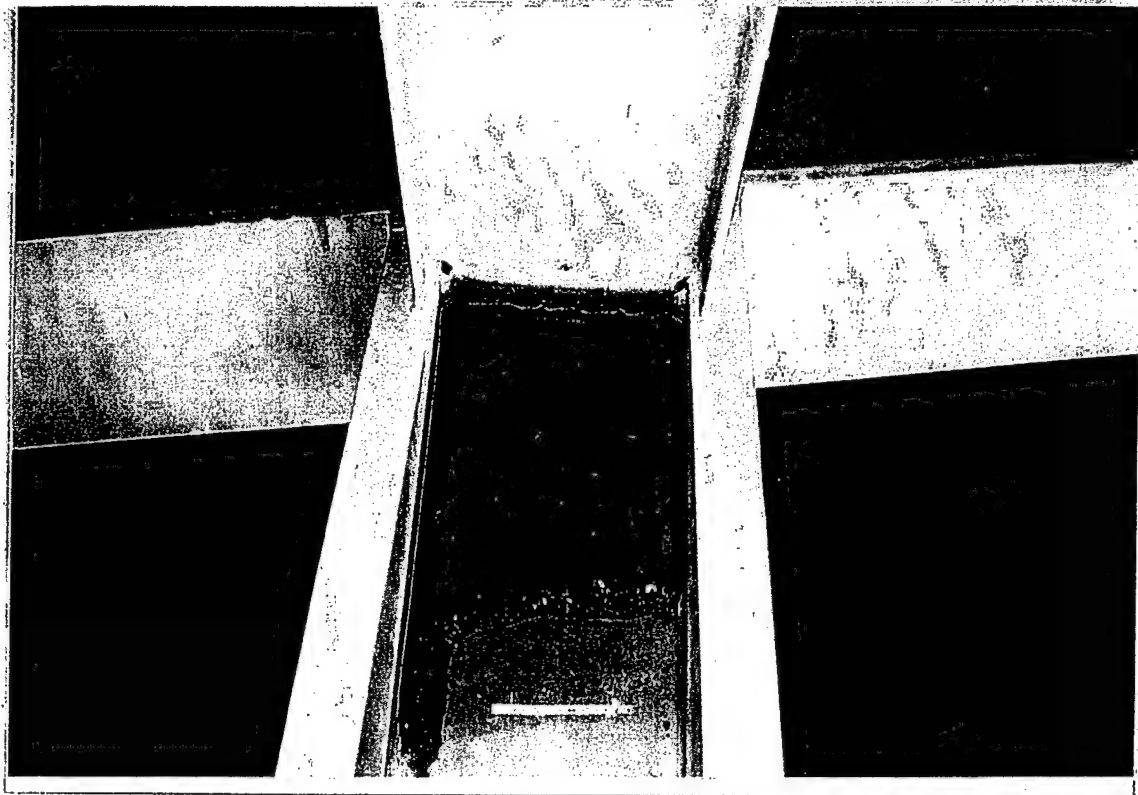
8-5

Gate 8  
Upstream end of bottom right strut.  
Standing water due to inadequate  
drainage.

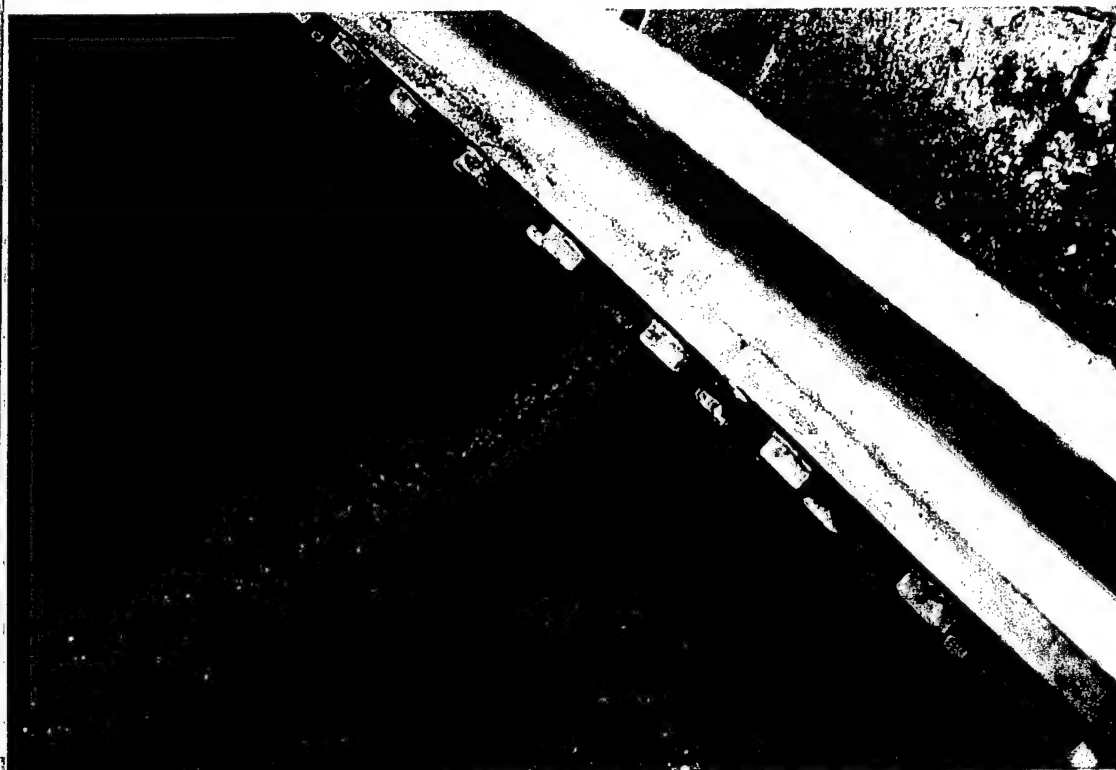
Bottom seal keeper plate and leak at  
center construction joint in spillway  
monolith.

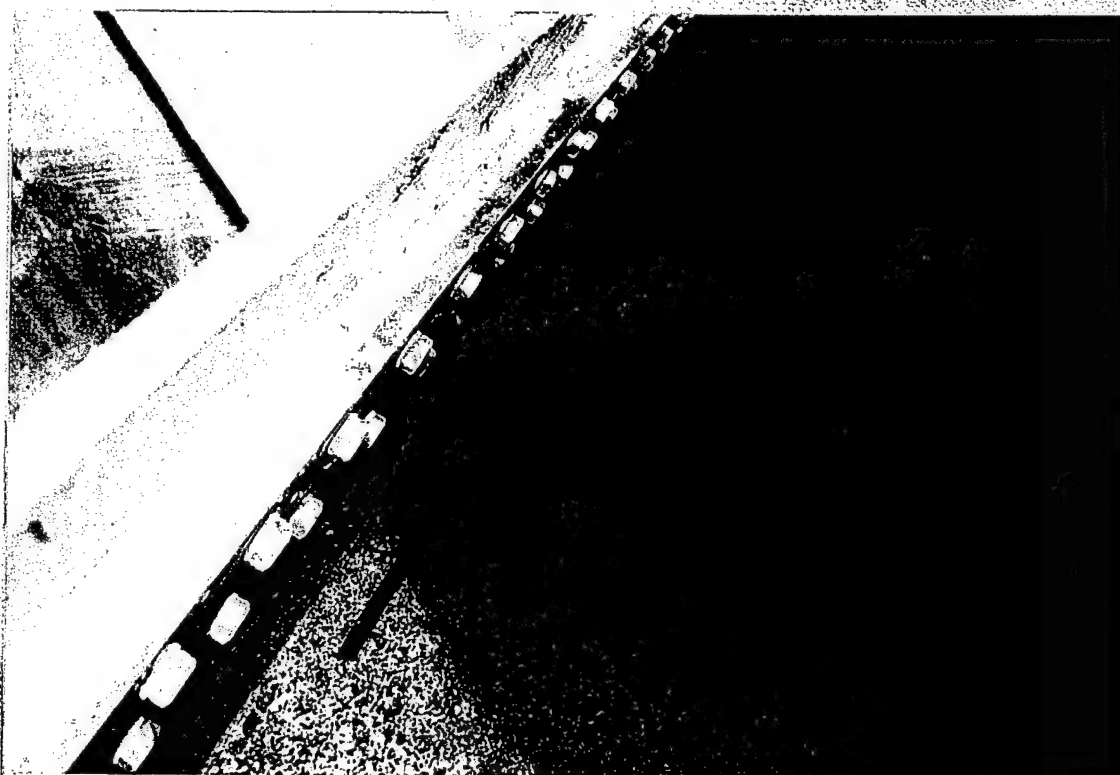
Downstream side of embedded  
bottom seal plate and small bottom  
left corner leak.
